**Flood Control Project Maintenance
Levee Inspections**
LMA District Cover Sheet
Spring 2018 Levee Inspection Results

Reclamation District No. 0563 Tyler Island

Spring 2018 Levee Inspection Results

Waterway			Bank	Unit Miles
Unit No. 01 Georgiana Slough (Tyler Island)			Left	12.11
	Spring (March - May)	Summer (June - August)	(September - November) Fall	Winter (December - February)
Unit Maintenance Rating (Fall Only)				
Date of Inspection	3/30/2018 - 3/30/2018			
DWR Inspector	Keith Millard			
Accompanied By	Steve Mello RD 563

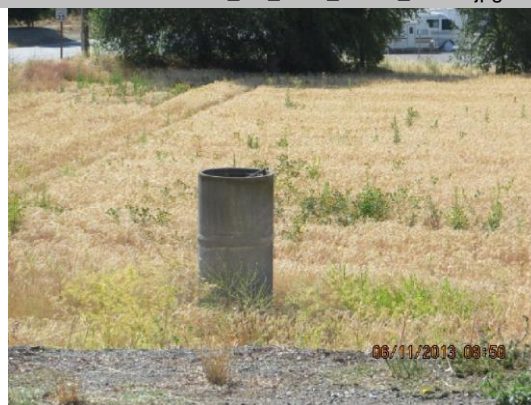
Photo 1 of 1 : UCIP_SP_2018_14864_24503.jpg

LM Start	0.02	Rating **	M	Issue No.	771	
LM End	0.02	Issue Type +	En	Location *		
Category	Supplemental			GPS Latitude/Longitude		
				Start		End
Item	DWR UCIP Field Study			38.234936 °	38.234936 °	
				-121.517528 °	-121.517528 °	
DWR ID						
Comment Code						
Inspector Comment						
FS_ID:14864 DS_ID:20199 EP_NO: N/A Repair Type: Non-Urgent Crossing Status: Indicator Found UCIP Comments: Need to determine disposition of pipe. Was it abandoned properly? FIELD_STRUCT_DESC: 10-inch steel irrigation pipe through the levee, at an unknown depth. 36-inch concrete standpipe at the landside (LS) toe. Unable to locate pipe, 06/11/2013. [Additional Reference(s): USACE Sacramento O&M Manual 103, June 1954, (Station ""L"" 6+39), listed as a 1-inch pipe and a 36-inch pipe]. FS Date: 6/11/2013

36-inch concrete standpipe on LS toe.

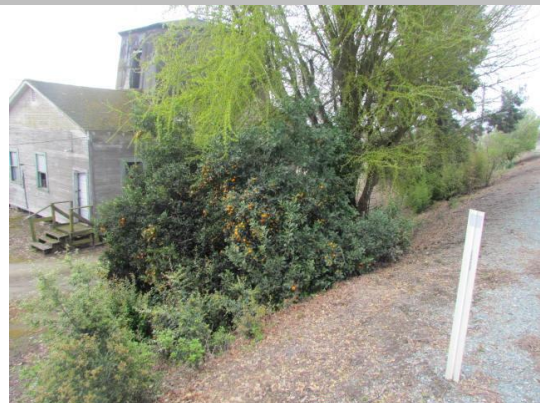
Photo 1 of 1 : SP_2018_RD0563_210_28_20180305_00020.jpg

Looking southeast at landscaping on landside slope and toe.

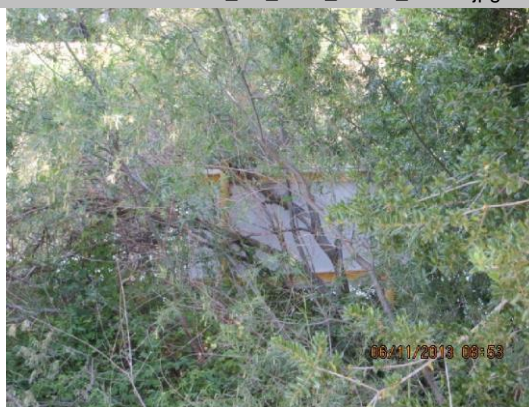
Photo 2 of 2 : UCIP_SP_2018_14865_24504.jpg

LM Start	0.20	Rating **	M	Issue No.	772
LM End	0.20	Issue Type +	En	Location *	
Category	Supplemental			GPS Latitude/Longitude	
				Start	End
Item	DWR UCIP Field Study			38.233027 °	38.233027 °
				-121.519631 °	-121.519631 °
DWR ID					
Comment Code					
Inspector Comment					
FS_ID:14865 DS_ID:20129 EP_NO: 3448 Repair Type: Non-Urgent Crossing Status: Indicator Found UCIP Comments: Sign on waterside slope should be cleared of vegetation. FIELD_STRUCT_DESC: 4.5-inch steel gas line through the levee, 4 feet below the crown and across the channel. Large warning sign on the waterside (WS) slope. (Permit No. 3448, 1960 - Pacific Gas and Electric Company [PG&E]). [Additional Reference(s): DWR Levee Log, 2005]. FS Date: 6/11/2013

Gasline warning sign covered in vegetation on WS slope.

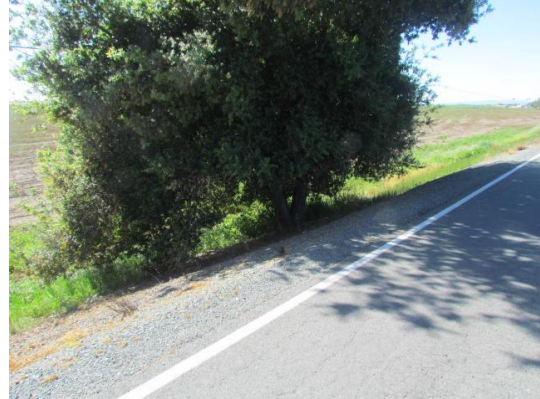
Photo 1 of 1 : SP_2018_RD0563_210_135_20180305_00113.jpg

Looking southeast at untrimmed tree on landward slope.

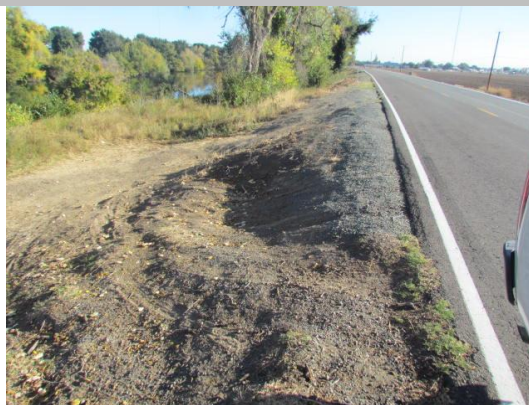
Photo 2 of 2 : SP_2018_RD0563_210_143_20180305_00121.jpg

LM Start	0.56	Rating **	M	Issue No.	143
LM End	0.56	Issue Type +	Ma	Location *	WS
Category	Earthen Levee			GPS Latitude/Longitude	
				Start	End
Item	Slope Stability			38.228930 °	38.228930 °
				-121.523935 °	-121.523935 °
DWR ID	DWR_RD0563_01_f_2014_143				
Comment Code					
S3 : Repair the levee slope damaged by vehicle traffic and prevent access where possible.					
Inspector Comment					
Slope damage due to vehicle traffic.

Looking northwest at slope damage on waterward slope.

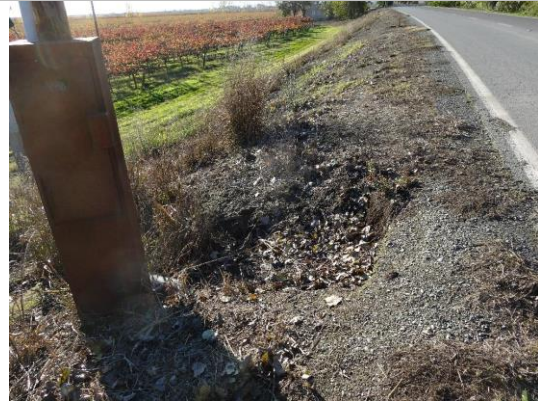
Photo 3 of 3 : UCIP_SP_2018_52608_76826.jpg

FS_ID:52608
DS_ID:20131
EP_NO: 11203
Repair Type: Urgent
Crossing Status: Found
UCIP Comments: 03/08/2018 LS pipe section replaced however, unable to determine the condition of the pipe section through the levee. LS levee section disturbed and has not been repaired. Crossing remains Urgent due to the unknown condition of the pipe section through the levee. (O. Magana - DWR UCIP)12/02/2016 Same as last inspection signs of leak are still present on both LS and WS. Recommend internal inspection of the pipe integrity though the levee to determine cause of depression on levee (either leak or poor compaction). Pipe debris previous noted on WS has been removed. (O. Magana - DWR UCIP)06/11/2013 Signs of leak in pipe at levee slope on both LS and WS where pipe enters levee. Moist soil at LS toe indicates possible internal leak. Evidence of recent pipe repair on WS. Pipe debris on WS toe should be removed. (W. Wylie - DWR UCIP) FIELD_STRUCT_DESC: 12-inch steel irrigation pipe through the levee, 5 feet below the crown. Slant pump located on the waterside (WS). Siphon breaker and switch box also located on the WS slope. Service pole is located on the landside (LS) slope. (12-inch pipe authorized under Automatic Board Order (ABO) issued as Permit No. 11203, 1971 - Delta Farmers, Inc.) This crossing has been replaced with 6-inch under DSID 25486, as reported by DWR inspector Richard Willoughby during his Spring 2017 inspection. [Additional Reference(s): DWR Levee Log, 2005. USACE Sacramento O&M Manual Unit 103, June 1954 (HLM 0.73)]

Subsidence visible on LS shoulder.

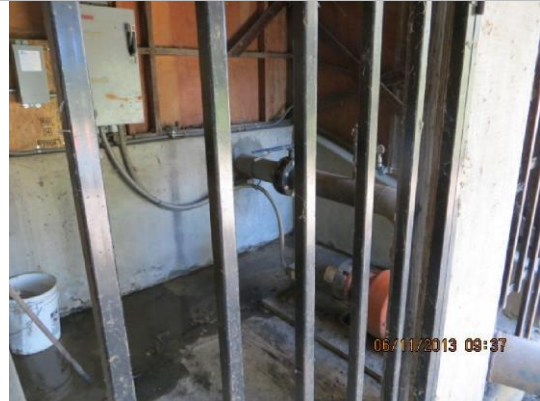
Photo 3 of 3 : UCIP_SP_2018_14870_24515.jpg

Comment Code						
Inspector Comment						
FS_ID:14870 DS_ID:20132 EP_NO: 11210 Repair Type: Non-Urgent Crossing Status: Found UCIP Comments: Pipe does not have sufficient cover at crown. FIELD_STRUCT_DESC: 1 of 2: 6-inch irrigation pipe of an unknown material through the levee, 3 inches below the crown. Pump and gate valve in pump house on the waterside (WS) slope. Service pole on the landside (LS) slope. (Automatic Board Order (ABO) issued as Permit No. 11210, 1975 - Leland O. Hanson). 1-inch polyvinyl chloride (PVC) electrical conduit through the levee at the same location, at an unknown depth. [Additional Reference(s): DWR Levee Log, 2005. USACE Sacramento O&M Manual 103, June 1954, (Station ""L"" 43+91.9), listed as a 14-inch pipe]. FS Date: 6/11/2013

Butterfly valve, vent and pump in pumphouse on WS shoulder.

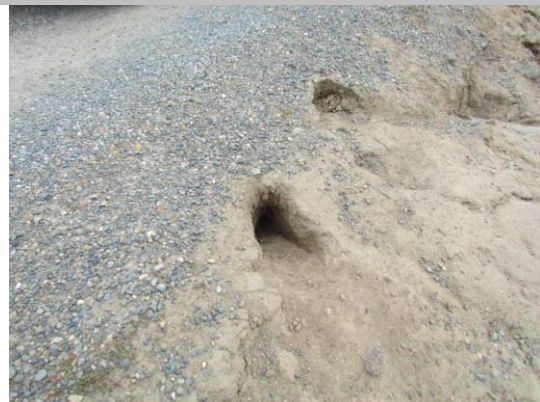
Photo 1 of 2 : SP_2018_RD0563_210_121_20180305_00100.jpg

LM Start	0.95	Rating **	U	Issue No.	121
LM End	0.95	Issue Type +	Ma	Location *	LS
Category	Earthen Levee			GPS Latitude/Longitude	
				Start	End
Item	Animal Control			38.225808 °	38.225808 °
				-121.528197 °	-121.528197 °
DWR ID	DWR_RD0563_01_s_2017_121				
Comment Code					
A1 : Exterminate rodents and backfill and compact or grout burrows.					
Inspector Comment					
Several large rodent holes on landward slope.

Looking at typical rodent hole within this reach.

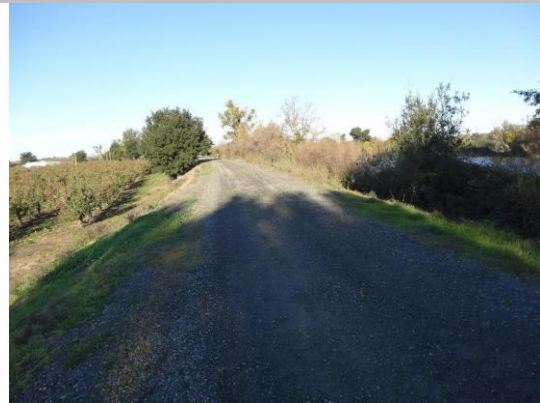
Photo 1 of 3 : UCIP_SP_2018_51448_76827.jpg

Comment Code						
Inspector Comment						
FS_ID:51448 DS_ID:20133 EP_NO: 11210 Repair Type: Non-Urgent Crossing Status: Found UCIP Comments: 12/02/2016 According to LMA representative, Darcy Neuderk, this crossing was installed in 1952 by the USACE and intended to be use for irrigation purposes. However, this crossing has never been used per LMA's knowledge. Crossing has been downgraded from "Urgent" to "Non-Urgent", the flap gate on the WS is functional and prevents any potential flood water from draining to LS. Recommend contacting property owner and working with the CVFPB to address abandoned crossing. (O. Magana - DWR UCIP)06/11/2013 Flap gate rusted in closed position. (W. Wylie - DWR UCIP) FIELD_STRUCT_DESC: 2 of 2: 8-inch steel drainage pipe through the levee, 3 feet below the crown. Flap gate on the waterside (WS). Pipe open on the landside (LS). (8-inch pipe [HLM 0.97] authorized under Automatic Board Order (ABO) issued as Permit No. 11210, 1975 - Leland O. Hanson). [Additional Reference(s): DWR Levee Log, 2005]. FS Date: 12/2/2016

View of levee crown at pipe crossing.

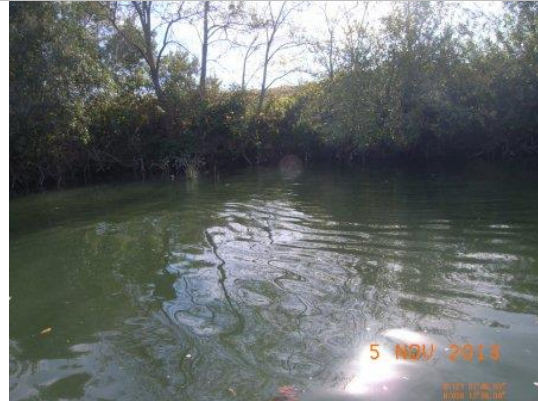
Photo 1 of 1 : SP_2018_RD0563_210_48_20180305_00037.jpg

LM Start	1.02	Rating **	M	Issue No.	48
LM End	1.06	Issue Type +	Ma	Location *	WS
Category	Supplemental			GPS Latitude/Longitude	
				Start	End
Item	2015 USACE Erosion Survey, DRAFT			38.226522 °	38.226808 °
				-121.529094 °	-121.529728 °
DWR ID	DWR_RD0563_01_s_2016_48				
Comment Code					
Inspector Comment					
2011 - Short sections of eroding bank at the waterline and holes in toe of levee. 2012 - Site extended upstream. 2013 - Erosion pockets filled with an insufficient amounts of revetment. 2015: Last observed in 2013. [2015 Site ID: GEO_11-0_L]

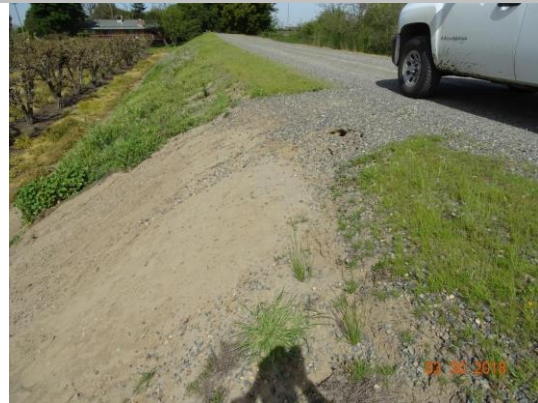
Photo 1 of 1 : SP_2018_RD0563_210_110_20180330_00240.jpg

LM Start	1.03	Rating **	U	Issue No.	110
LM End	1.03	Issue Type +	Ma	Location *	LS
Category	Earthen Levee			GPS Latitude/Longitude	
				Start	End
Item	Animal Control			38.226422 °	38.226422 °
				-121.529410 °	-121.529410 °
DWR ID	DWR_RD0563_01_s_2018_110				
Comment Code					
A3 : No rodents visible, but rodent burrows visible; need to backfill and compact or grout burrows.					
Inspector Comment					
Very large rodent burrow has caused landside shoulder to collapse. Shoulder should be restored.

3/30/2018: Very large rodent burrow causing caving at landside shoulder.

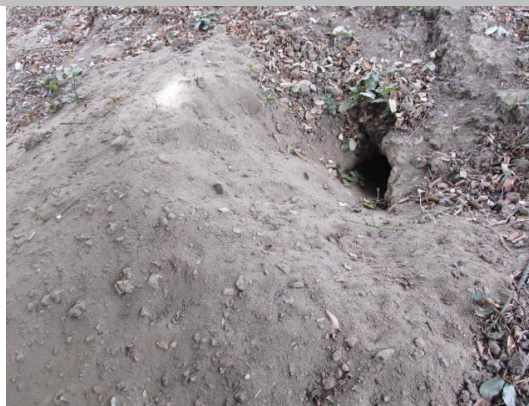
Photo 1 of 1 : SP_2018_RD0563_210_153_20180305_00127.jpg

LM Start	1.15	Rating **	U	Issue No.	153
LM End	1.15	Issue Type +	Ma	Location *	LS
Category	Earthen Levee			GPS Latitude/Longitude	
				Start	End
Item	Animal Control			38.226910 °	38.226910 °
				-121.531294 °	-121.531294 °
DWR ID	DWR_RD0563_01_f_2015_153				
Comment Code					
A3 : No rodents visible, but rodent burrows visible; need to backfill and compact or grout burrows.					
Inspector Comment					
Several large to medium rodent holes noted.

Looking at typical view of several rodent holes on landward slope.

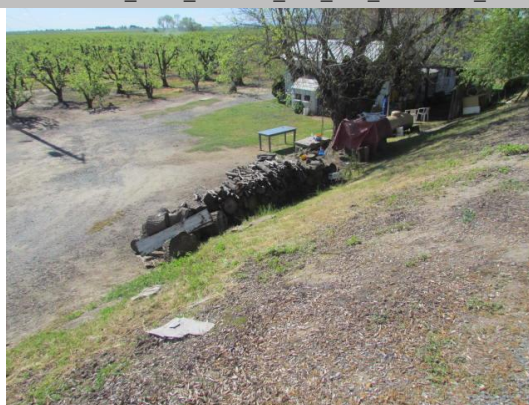
Photo 2 of 2 : SP_2018_RD0563_210_134_20180305_00112.jpg

Looking southeast at firewood at landward toe. (Spring 2016)

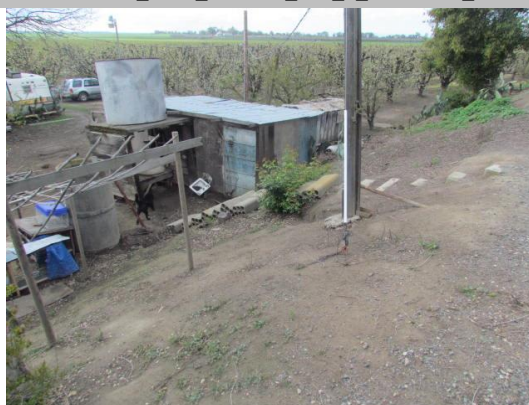
Photo 3 of 3 : SP_2018_RD0563_210_8_20180305_00006.jpg

Looking southeast at a tool shed at the landside toe.

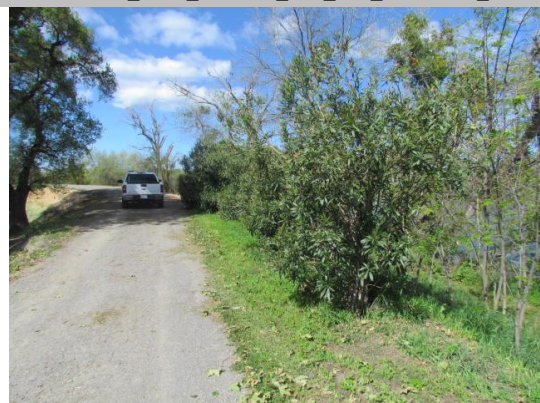
Photo 1 of 4 : SP_2018_RD0563_210_142_20180305_00116.jpg

Looking southwest at oleanders on landward shoulder.

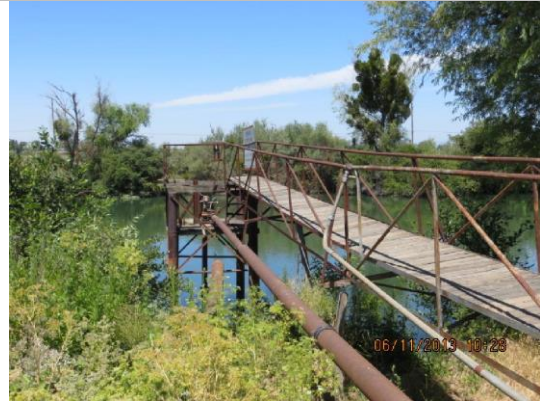
Photo 1 of 3 : UCIP_SP_2018_51449_24537.jpg

Pump on pile structure with walkway structurally failing. WS berm.

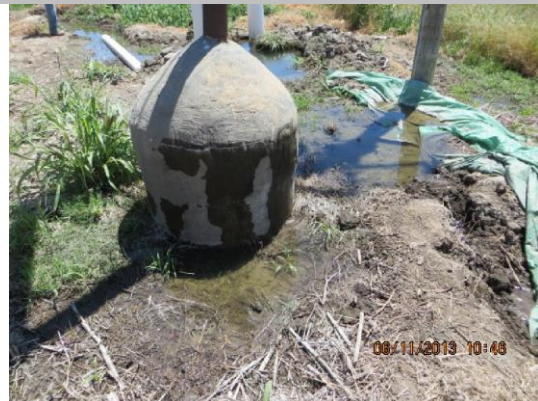
Photo 3 of 3 : UCIP_SP_2018_51450_24539.jpg

Leaks around standpipe on LS toe.

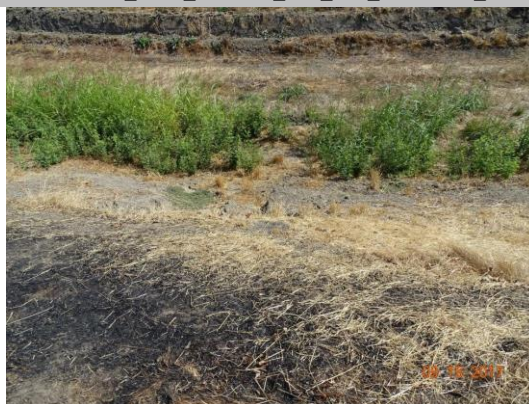
Photo 1 of 1 : SP_2018_RD0563_210_116_20180305_00096.jpg

Looking east at the landside toe erosion.

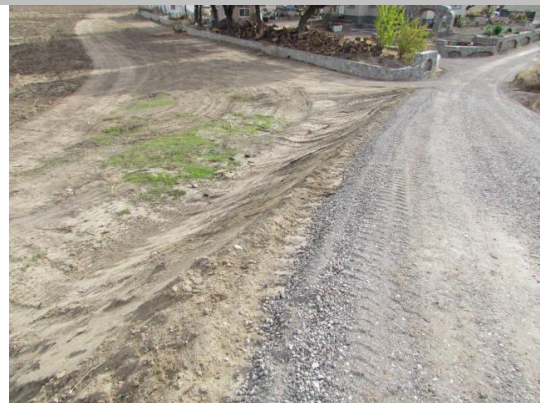
Photo 1 of 2 : SP_2018_RD0563_210_80_20180305_00071.jpg

Looking east at unauthorized ramp on landside slope.

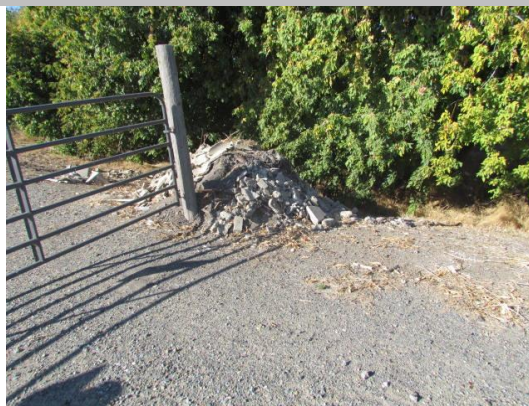
Photo 1 of 2 : SP_2018_RD0563_210_104_20180305_00089.jpg

Looking west at concrete rubble on waterward shoulder and slope.

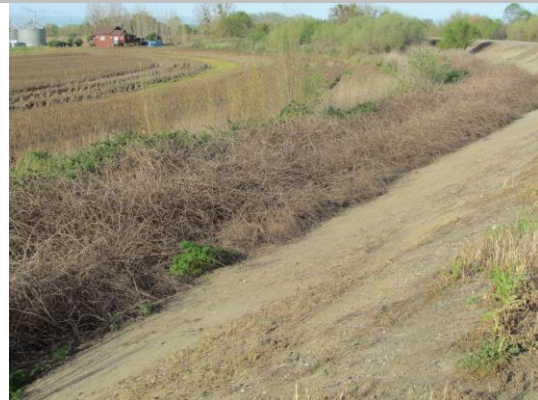
Photo 1 of 5 : SP_2018_RD0563_210_74_20180305_00055.jpg

Looking southeast at dead berryvines along landward toe and berm.
(Spring 2017)

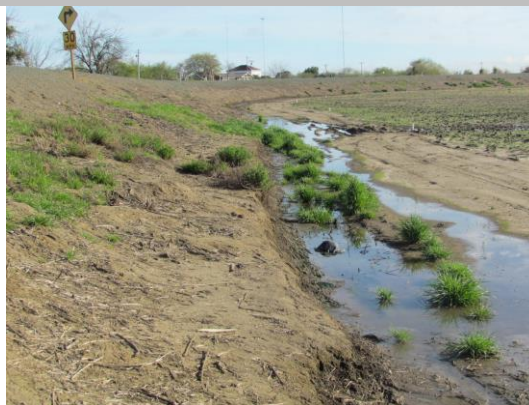
Photo 4 of 4 : SP_2018_RD0563_210_125_20180305_00107.jpg

Looking northwest at cut along farm's service road at landward toe.

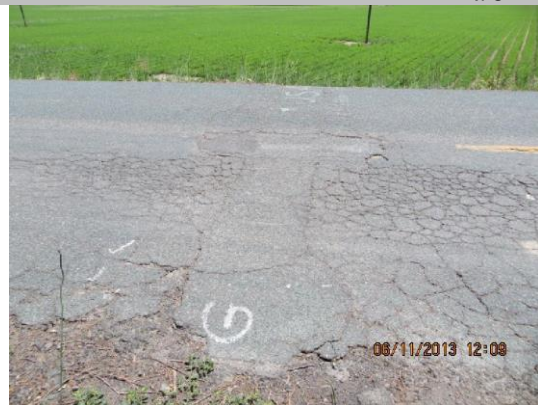
Photo 1 of 3 : UCIP_SP_2018_16244_27390.jpg

Cut in pavement with USAA markings for gasoline.

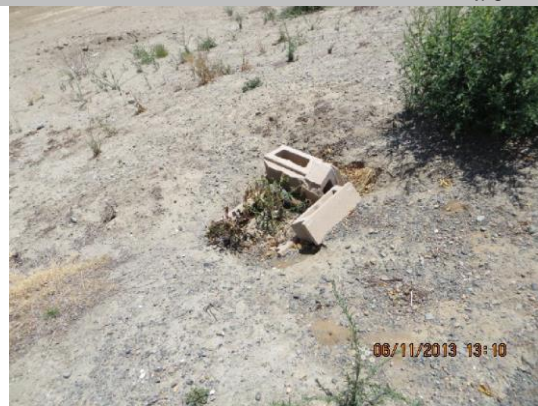
Photo 1 of 3 : UCIP_SP_2018_14950_24607.jpg

Vent/filler pipe exposed on LS shoulder.

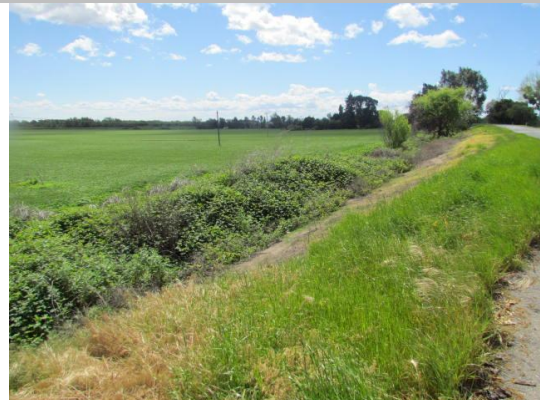
Photo 1 of 1 : SP_2018_RD0563_210_164_20180305_00130.jpg

Looking east at dense vegetation (vines) at landward toe.

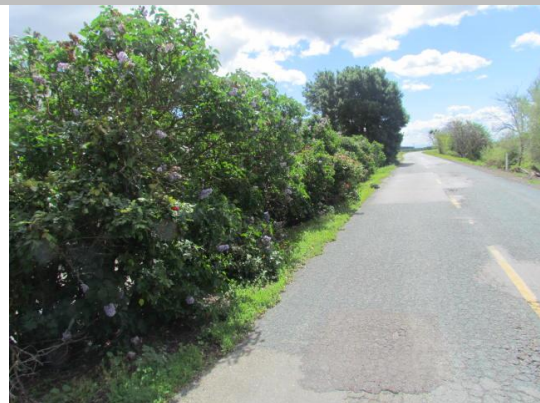
Photo 1 of 1 : SP_2018_RD0563_210_75_20180305_00060.jpg

Looking south at dense landscaping on landward shoulder and slope.
(Spring 2016)

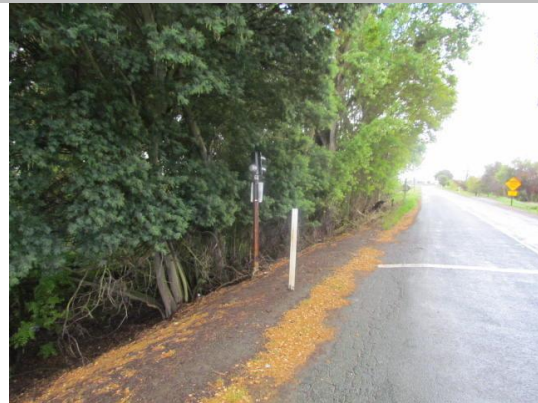
Photo 1 of 1 : SP_2018_RD0563_210_29_20180305_00021.jpg

Looking southeast at dense trees on landward slope and toe.

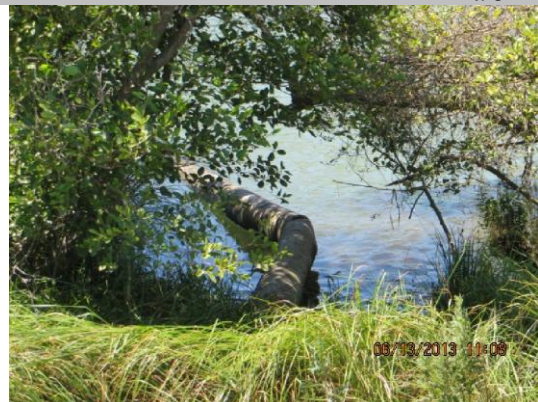
Photo 1 of 3 : UCIP_SP_2018_16292_27453.jpg

Pipe visible on WS toe. See damage to pipe at bend.

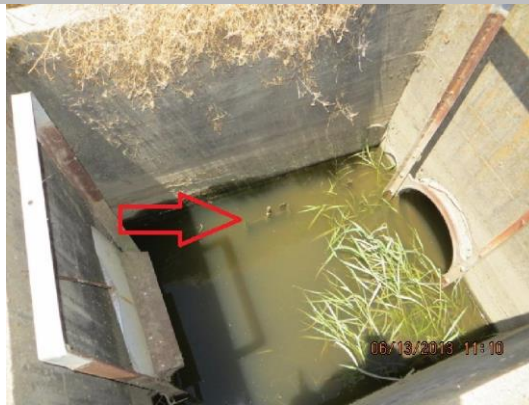
Photo 3 of 3 : UCIP_SP_2018_16292_27451.jpg

Broken slide gate in 7'X9' concrete distribution box on LS toe.

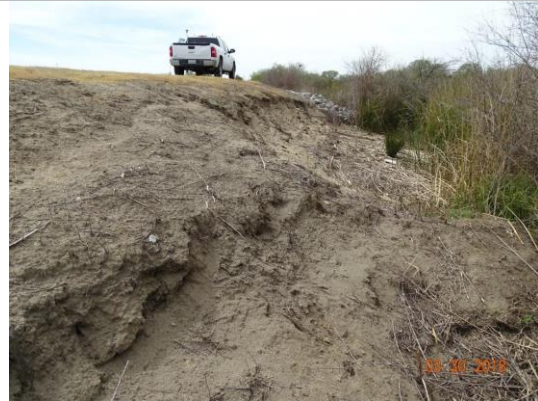
Photo 1 of 1 : SP_2018_RD0563_210_124_20180330_00243.jpg

Erosion in sandy levee should be repaired and site protected from future erosion.
